Office floor vibrations: modal parameter identification and vibration monitoring

R. Cantieni
rci dynamics, Structural Dynamics Consultants, Duebendorf, Switzerland

T. Biro
GeoSIG Ltd., Glattbrugg, Switzerland

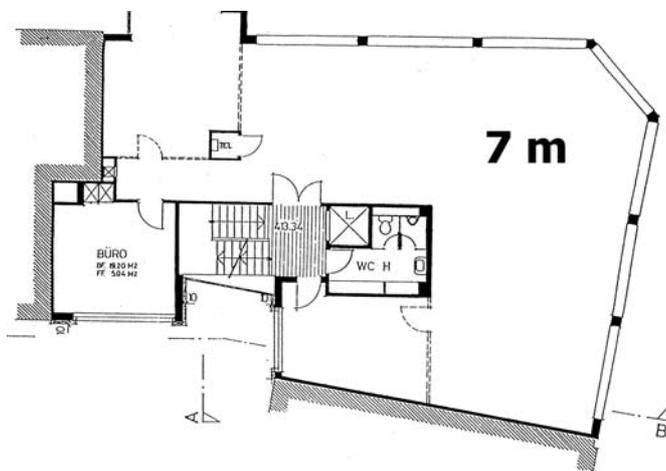
Figure 1. Plan view of the 1st and 2nd floors (cut above the slab and looking down on the slab).

In the contrary to the other floors, the 2nd floor has no floor-to-ceiling secondary walls neither beneath nor on top of the slab (Fig. 1). The other three floors have some floor-to-ceiling secondary walls either beneath (1st and 4th floor) or on top of the slab (3rd floor) (Figs. 2 and 3). Theoretically, these secondary walls are not load-carrying.

This easily explains the fact that problems were encountered with the 2nd floor but not with the other floors.

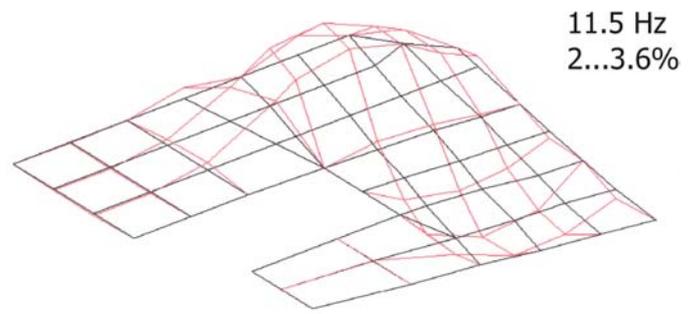
Figure 6. Mode 1, 1st floor

11.5 Hz
2...3.6%

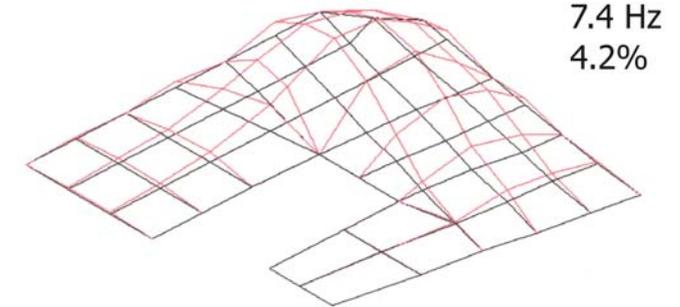
Figure 7. Mode 1, 2nd floor.

7.4 Hz
4.2%

As can be taken from Bachmann & Ammann (1987) and Bachmann ed. (1995), problems with concrete floor vibrations excited through walking people can be expected if f < 7.5 Hz.

a) The stiffening action of floor-to-ceiling walls located on top of a concrete floor is obviously much more important than their mass effect. There is no other explanation for the 3rd floor fundamental natural frequency being a factor of 1.6 higher than the one of the 2nd floor (with exhibiting an almost identical mode shape!).

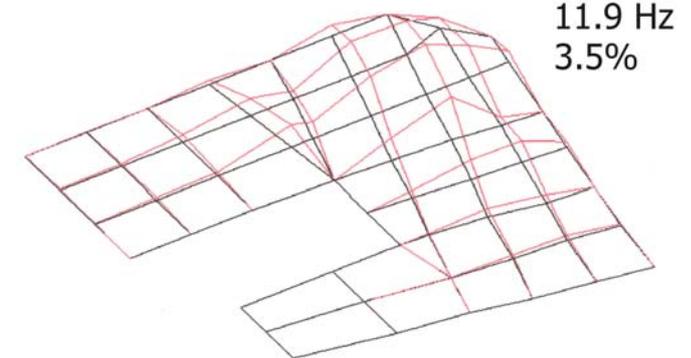
Figure 8. Mode 1, 3rd floor.

11.9 Hz
3.5%

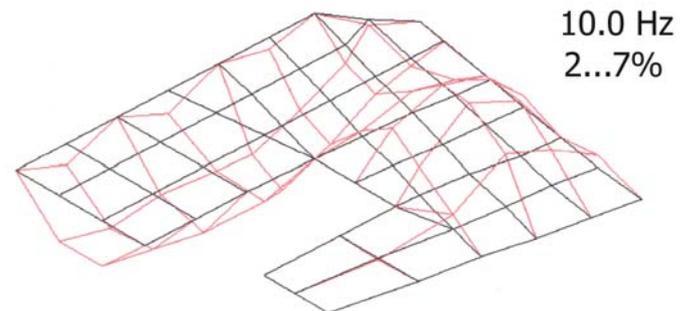
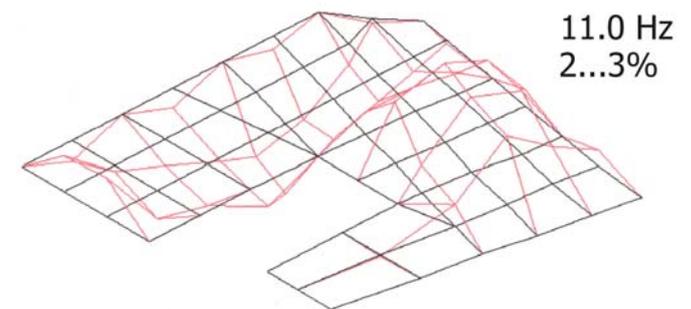
Figure 10. Mode 3, 2nd floor.

11.0 Hz

2...3%

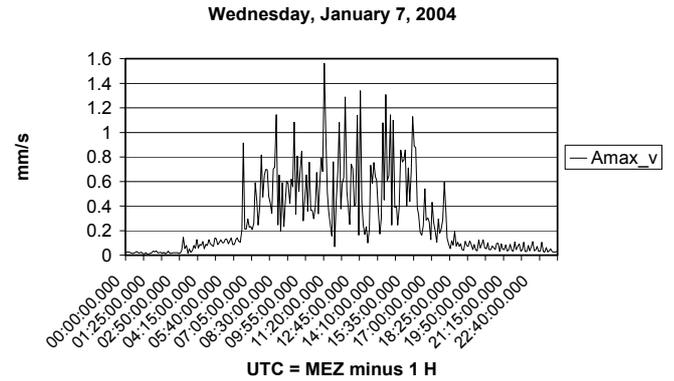
Figure 12. Floor vibrations for a typical normal working day.

Many people walking on the floor resulted in maximum vectorial velocity amplitude values in the range $a_{max}v = 0.8…2.5$ mm/s (1.34 mm/s on the average).

b) the vibration level measured for normal working conditions is mainly between the levels "just perceptible" and "clearly perceptible".

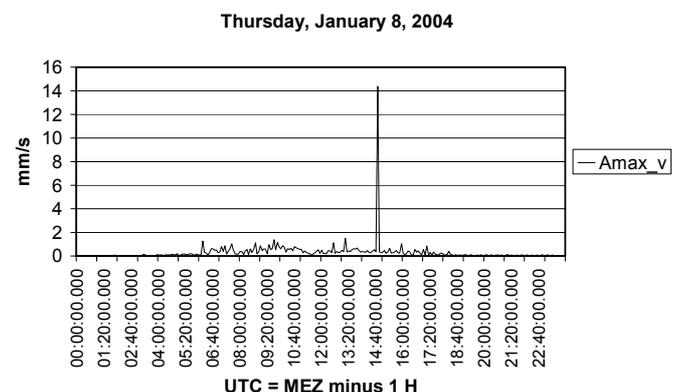
Figure 15. Normal working day with a singular event.

Figure 15 shows the diagram for a normal working day with one singular event. It was not possible to identify the source of this singular event. Probably, somebody "stumbled" over the velocity sensor.

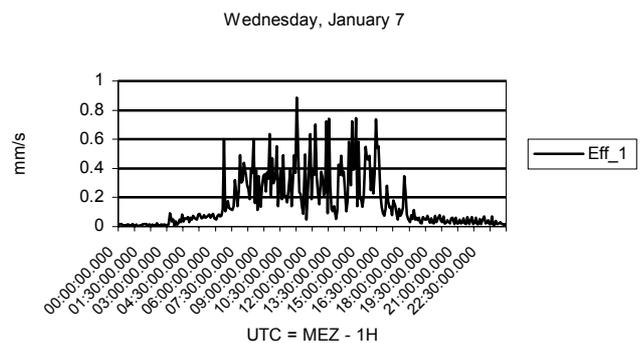
Figure 16. Floor vibrations for a typical normal working day.

a) normal working day: $v_{RMS} = 0.47…1.45$ mm/s, 0.8 mm/s on the average,

b) nobody present: $v_{RMS} = 0.07…0.17$ mm/s, 0.11 mm/s on the average.

In summary: During working hours, the vibration level is up to 3.6 times higher than "satisfactory" according to ISO 2631. The vibration level valid for the state "nobody present in the building" is well below the "satisfactory" level according to ISO 2631.

At the moment, discussions are ongoing to find an optimum solution for the problem.

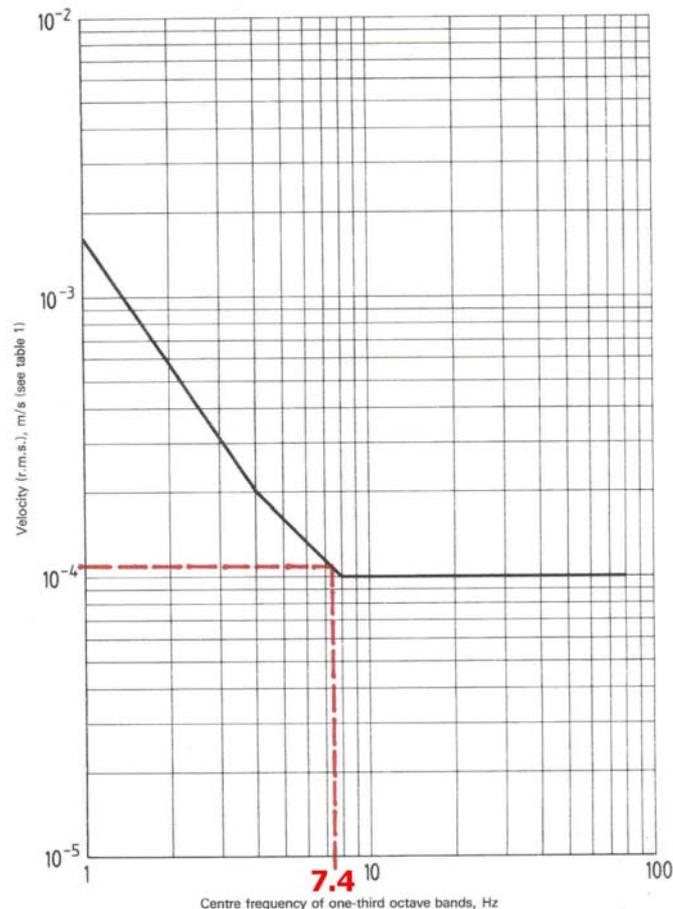
Figure 18. Base value for f = 7.4 Hz (ordinate's scaling: m/s).

For office buildings, "continuous or intermittent vibration", "day" and "night", Table 2 of ISO 2631-2 (1989) gives a multiplication factor 4. Multiplying this factor with the base value yields, that vibration levels (RMS velocity) of v < 0.4 mm/s "have been found to be satisfactory".
